CLOSEOUT REPORT FOR THE FROG POND DRAINAGE

WELDON SPRING SITE REMEDIAL ACTION PROJECT
WELDON SPRING, MISSOURI

OCTOBER 2000

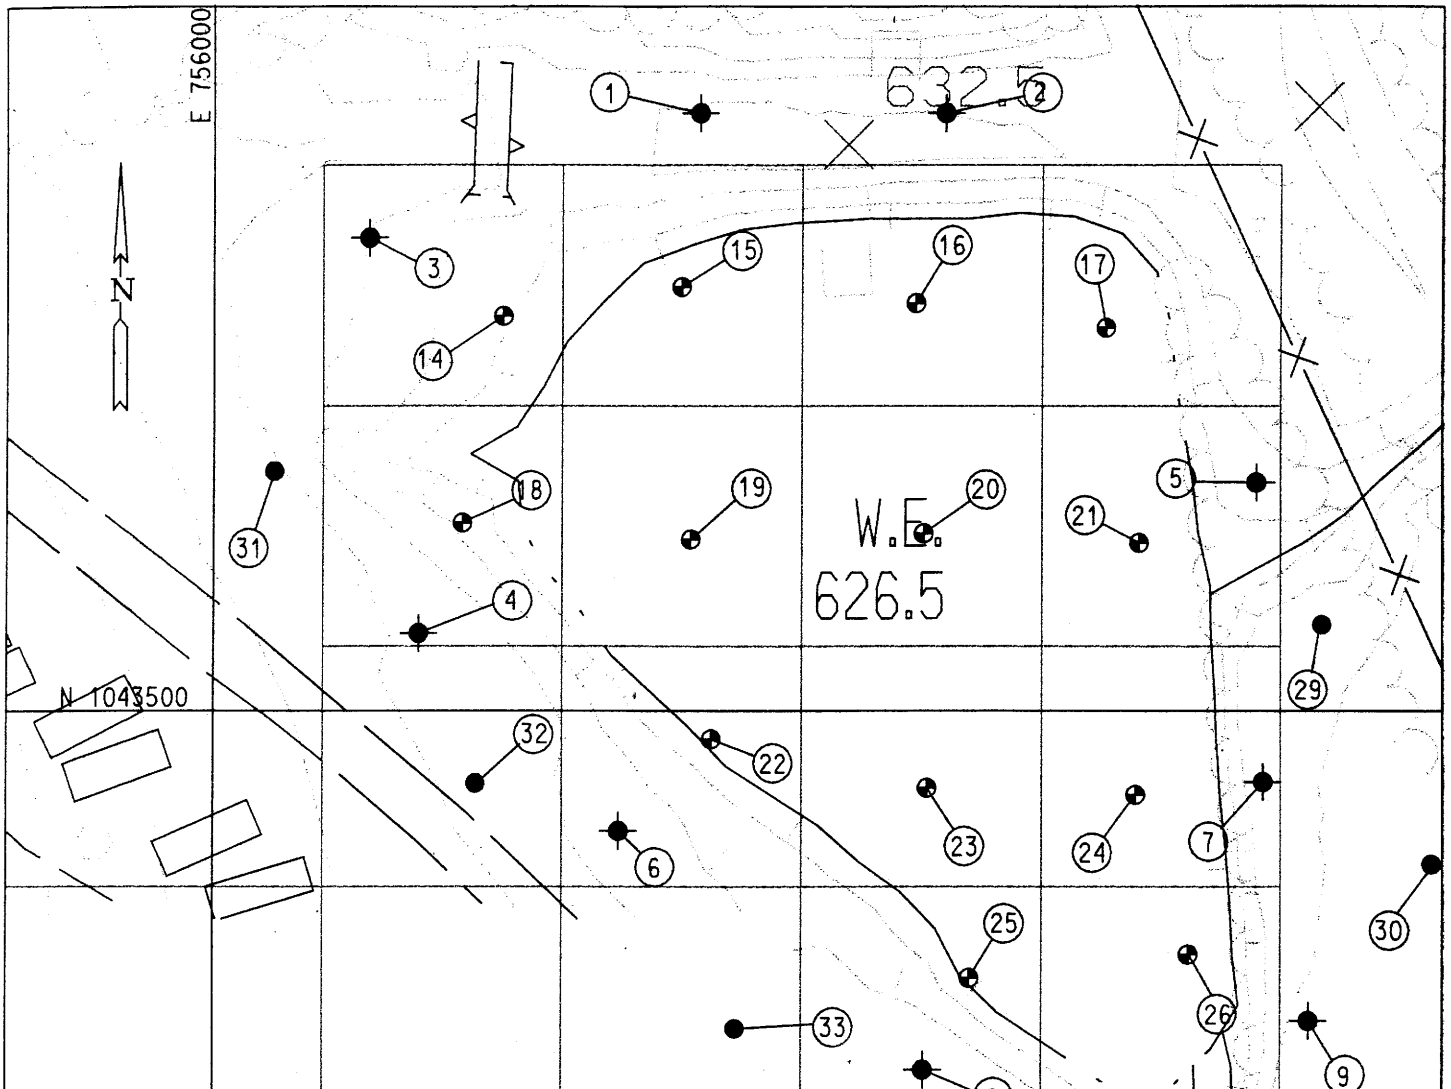
FIGURE 2-2

- 12 FT. INSIDE
- 16 FT. OUTSIDE

**FROG POND CHARACTERIZATION
SAMPLE LOCATIONS**

Engineering characterization was performed on all three sections of the Frog Pond drainage area (the Frog Pond area, the Frog Pond drainage, and the Frog Pond outlet). The Frog Pond area was characterized from October 1997 to January 1998 under the *Frog Pond Characterization Sampling Plan* (Ref. 6). The pond was drained prior to sampling. Samples were collected from 15 locations within the Frog Pond area and 18 locations surrounding the

pond (Figure 2-2). Samples were collected at 1 ft intervals to a depth of 12 ft for inner Frog Pond samples and to a depth of 16 ft at locations outside the pond. Analysis revealed that five locations exhibited elevated concentrations for a single ROD chemical constituent. These boreholes consisted of sample locations: 2, 8, 12, 13, and 28. Eighteen other sample locations exhibited elevated concentrations for multiple ROD chemical constituents, radioactive constituents, or both. These boreholes consisted of sample locations: 4, 6, 7, 14, 15, 16, 17, 18, 19, 20, 21, 22, 23, 24, 25, 26, 27, and 31. Data generated from this sampling activity is summarized in Table 2-3. Additional information may be found in the *Analytical Data Results for the Frog Pond Characterization Sampling Plan* (Ref. 7).

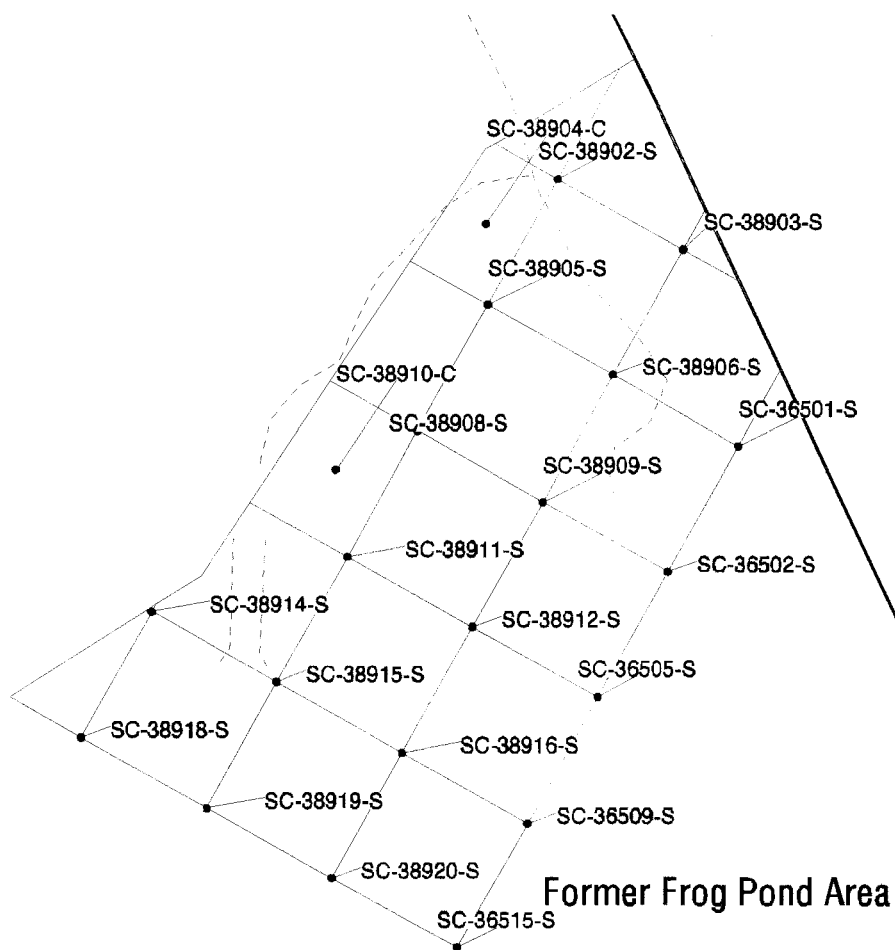
Figure 4-5

**Sample Locations in Remedial Unit RU016
Confirmation Unit CU389**

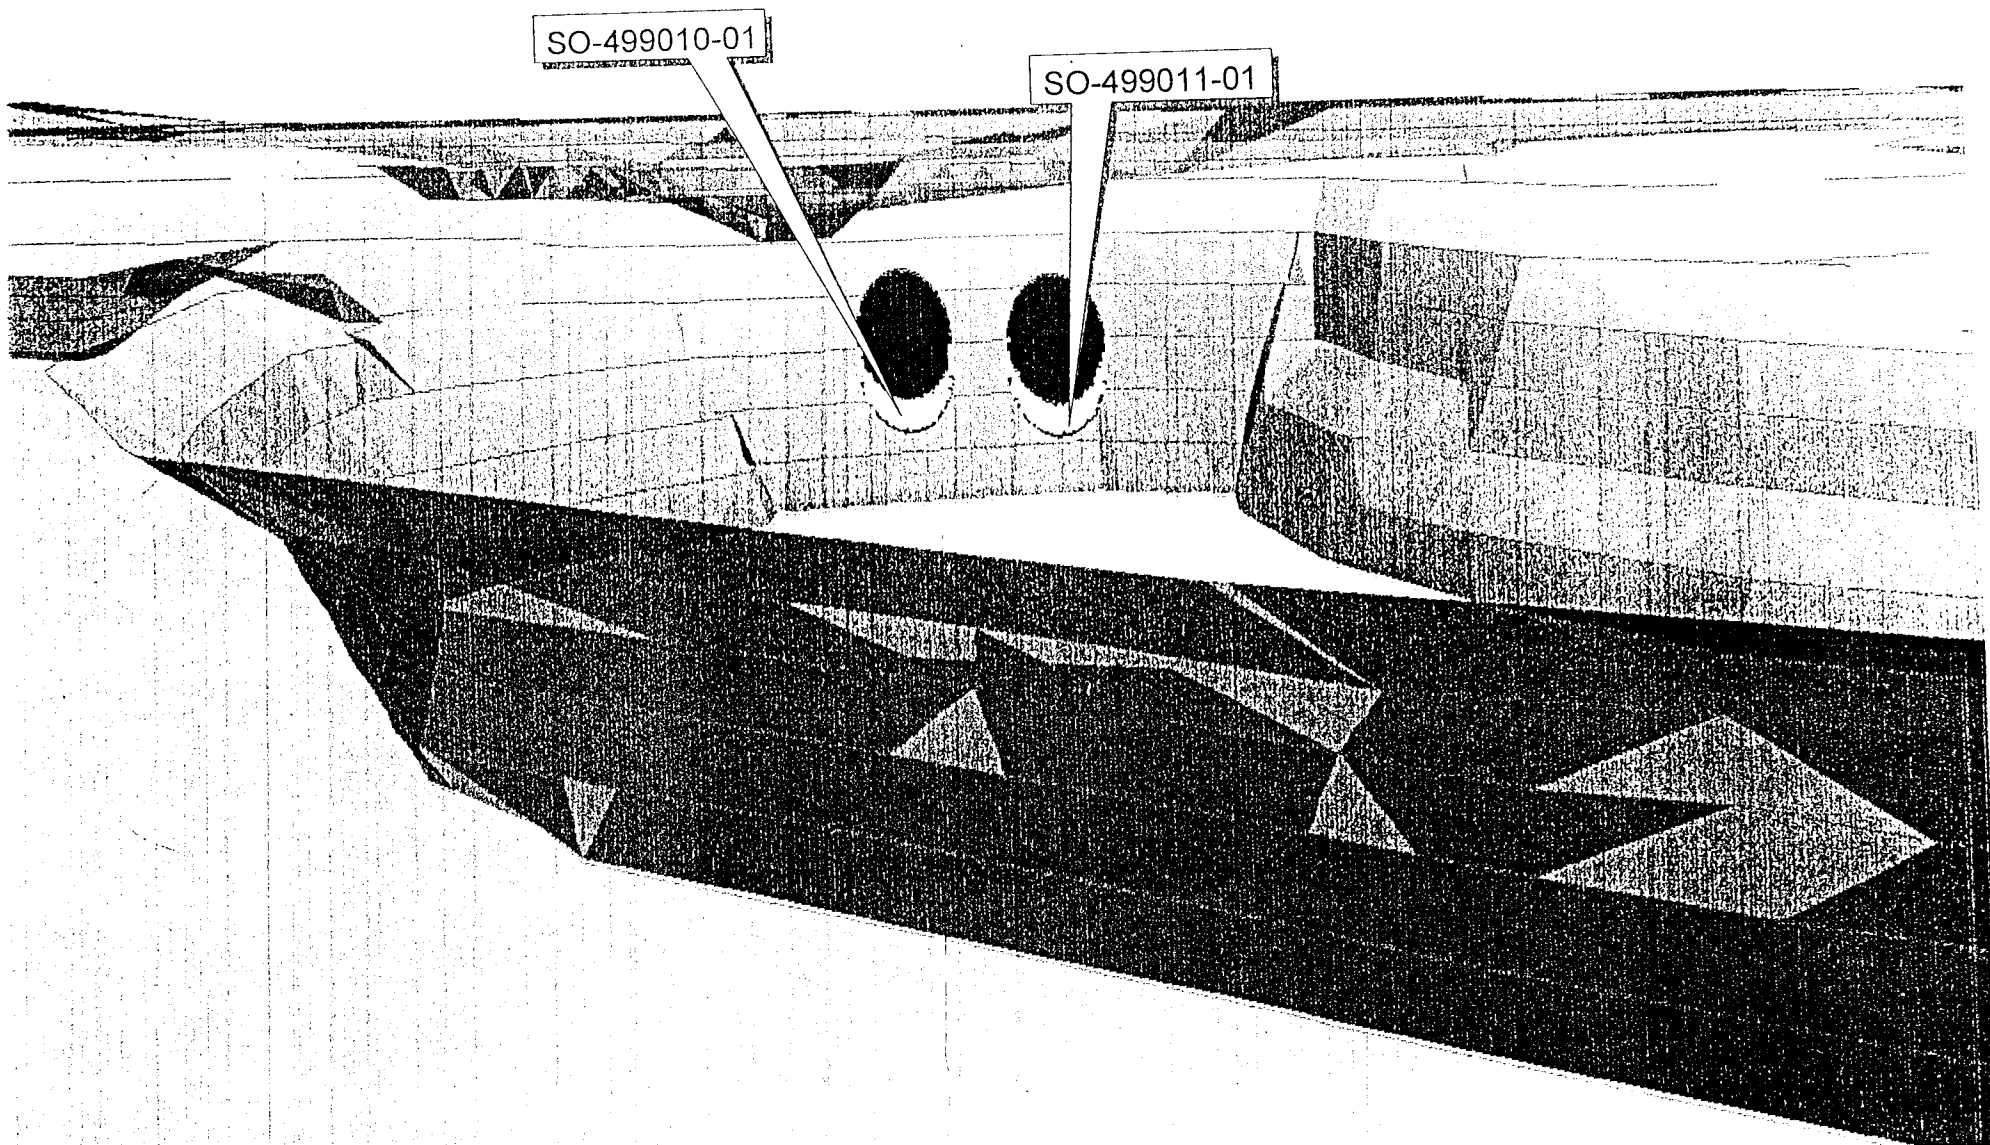
Sample ID #	Northing	Easting	Surface Elevation	U-238 Concentration
SO-499010-01	1045527.23	755255.05	588.50	310.0 pCi/g
SO-499011-01	1045524.55	755248.56	588.19	48.4 pCi/g

- None of the characterization results for Frog Pond Outlet or the Frog Pond Drainage exceeded three times criteria. Several small areas of approximately 300 pCi/g were found. The results are attached and Figure C shows the locations. The other end of the culverts was sampled, but samples were not collected directly under the culverts per the locations designated in the respective sampling plan (i.e. no material was accessible under the culverts for surveying and therefore not targeted). Two locations were sampled in soil/sediment within a few feet of the culvert and results for these samples were less than ALARA.
